# RESULTS OF ACCELERATED AGING TESTS OF EXTERNAL LIGHTNING CONNECTION COMPONENTS ACCORDING EN 50164-1

## Abstract

Since Benjamin Franklin invented the lightning rod, buildings and installations have been protected against direct lightning strokes. New standards define the accelerated aging of materials such as connecting components, conductors. This paper describes the application of the technology for such tests in laboratory, first results and conclusions for the best combination of materials.

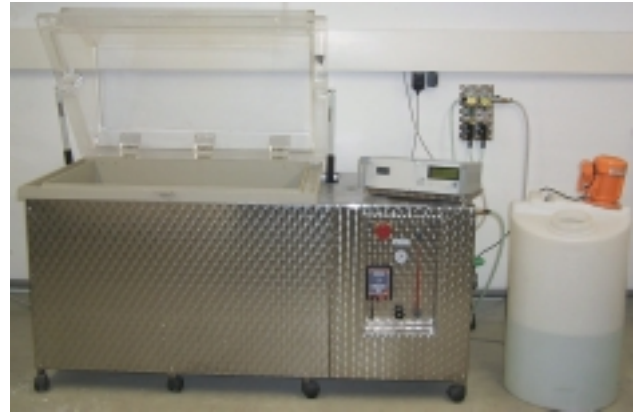
**Fig.2** Apparatus for accelerated artificial aging.

According to Table 1 the specimen have to be prepared using different chemical treatments. Fig.2 and 3 show the installed equipment for such chemical treatments. Fig 4 shows the measurement of loosening torque's for screwed clamps.

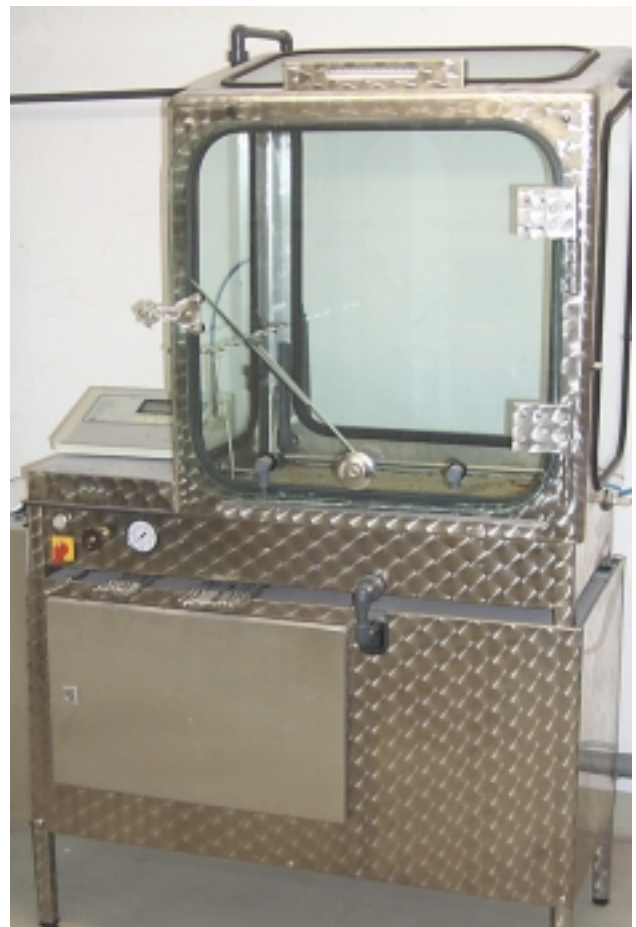
**Fig. 3** Apparatus for accelerated artificial aging. (SO<sub>2</sub>)

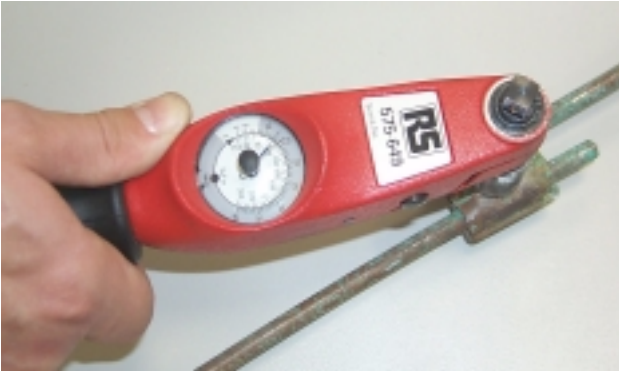
**Fig. 4** Measurement of loosening torque

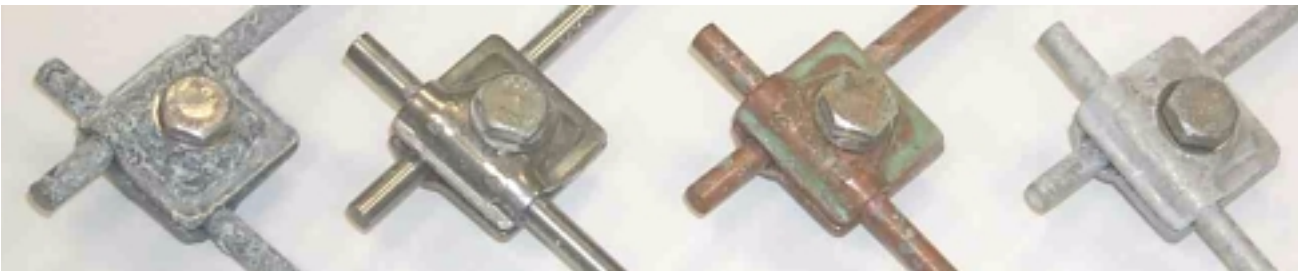
**Fig.6** Arrangements after chemical treatment (Salt mist). All Bolts are made from stainless steel.  
 Conductor and clamp, from left to right: hot dipped galvanized steel; stainless steel; copper, Aluminium.

Table 2 shows the matrix of tested arrangements of materials and their combination. Fig. 5 shows the pictures of tested arrangements of rods and clamps in original condition before accelerated aging using chemical treatment. Fig 6 and fig.7 show the same arrangements after different chemical treatment according to table 1. Fig.8 shows same arrangement after impulse current test using 10/350µs wave with 100 kA peak value.

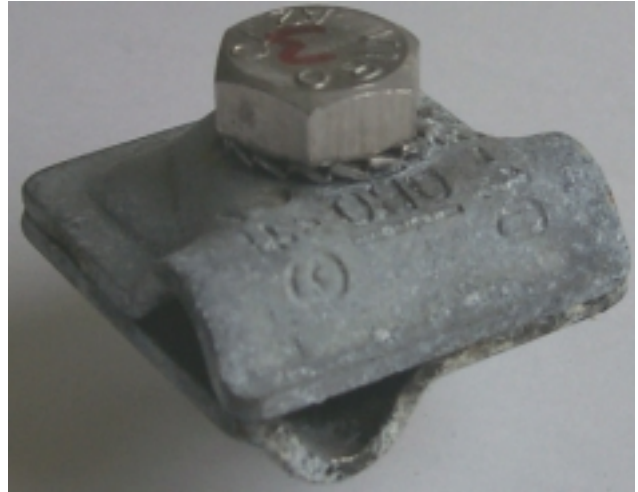
**Fig.9a.** Bottom view of a vario quick connector after test with lightning impulse current 10/350µs and 100 kA peak value.

**Fig.9b.** Top view of a vario quick connector .

have successfully passed the test with class H. All other combinations of materials were successful and passed the class H. Fig. 9 shows the detailed view of the vario quick connector after testing with impulse current 10/350µs with 100 kA peak value. The toothed lockwasher was damaged due to the current flow and had lost its mechanical properties. Afterwards the bolts were loose and mechanical and electrical reliable connection was no longer given. This result required a new washer as shown in fig.10. The toothed lockwasher was therefore replaced
